# **Environmental Exposure Effects on DOT-CFFC Cylinders with Modal Acoustic Emission Examination**

**JUNE 2015**

US DOT/PHMSA  
Mark Toughiry, PE  
1200 New Jersey Ave, SE  
Washington, DC 20590  
+1 (202) 366 – 4545

Digital Wave Corporation  
Dr. Brian Burks, Dr. Steven Ziola, Dr. Michael Gorman  
13760 E Arapahoe Road  
Centennial, CO 80112  
+1 (303) 790-7559 x13

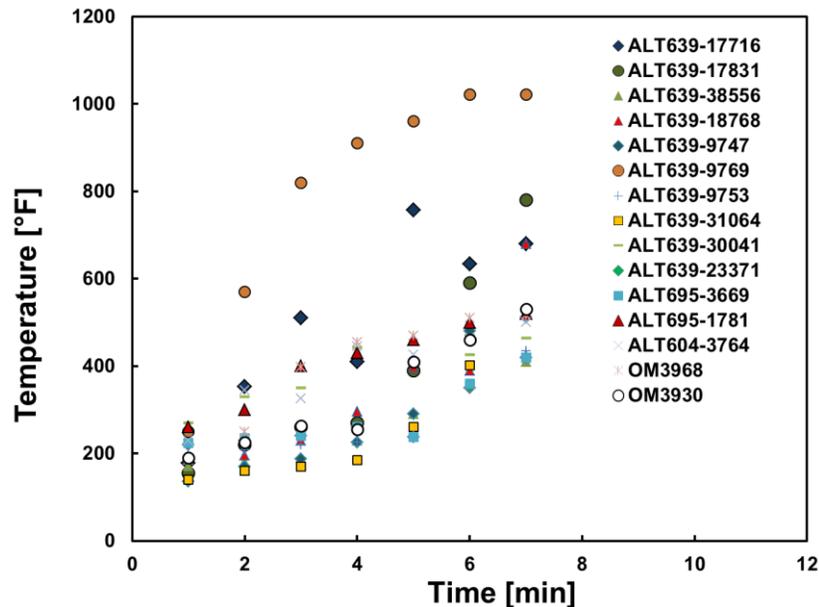
Figure 3.6 provides the temperature of all fifteen (15) cylinders which were subjected to fire exposure. From Figure 3.6, it is observed that in general the temperature of the cylinders increased exponentially. Also observed in Figure 3.6 was that cylinders ALT639-9769, ALT639-17831, and ALT604-3764 experienced the highest temperatures during the fire exposure test. As will be shown in the Visual Inspection Results, and the EOL Burst Results sections the aforementioned cylinders were the cylinders most severely impacted by the fire exposure.

Figure 3.6 – Temperature as a function of exposure time for all fifteen fire exposed cylinders.

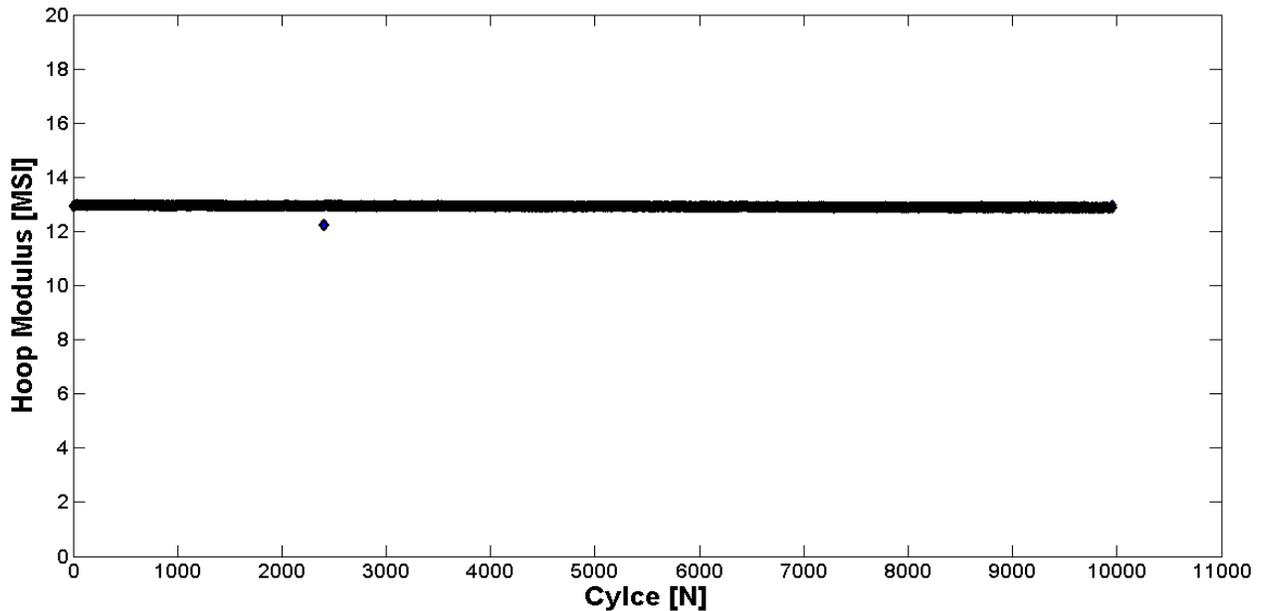
**Figure 6.10 – Hoop modulus as a function of the number of applied fatigue cycles for ALT639 – 9753.**

Of the five (5) cylinders which were subjected to fatigue cycle testing after fire exposure, only one cylinder achieved the required 10,000 fatigue cycles (equivalent to a simulated 20 additional years of service), with the other four cylinders leaking prior to achieving 10,000 fatigue cycles. The total number of fatigue cycles to maximum developed pressure during fast fill for the five fatigue cycled cylinders is summarized in Table 6.6. The reason four of the five cylinders leaked during fatigue cycling was due to annealing the 6061-T6 Aluminum liner. It is well known that for the 6061 Aluminum alloy, increased levels of annealing result in a diminished fatigue endurance limit and accelerated crack growth rates [16, 17]. Hence, while the re-autofrettage process of the DOT-CFFC aluminum liner prior to the fatigue cycling test has repeatedly been shown to enhance liner fatigue performance (Section 6.2 - 6.4 and [5]), it was unable to mitigate liner leakage on fire exposed DOT-CFFC cylinders due to the aluminum being annealed.

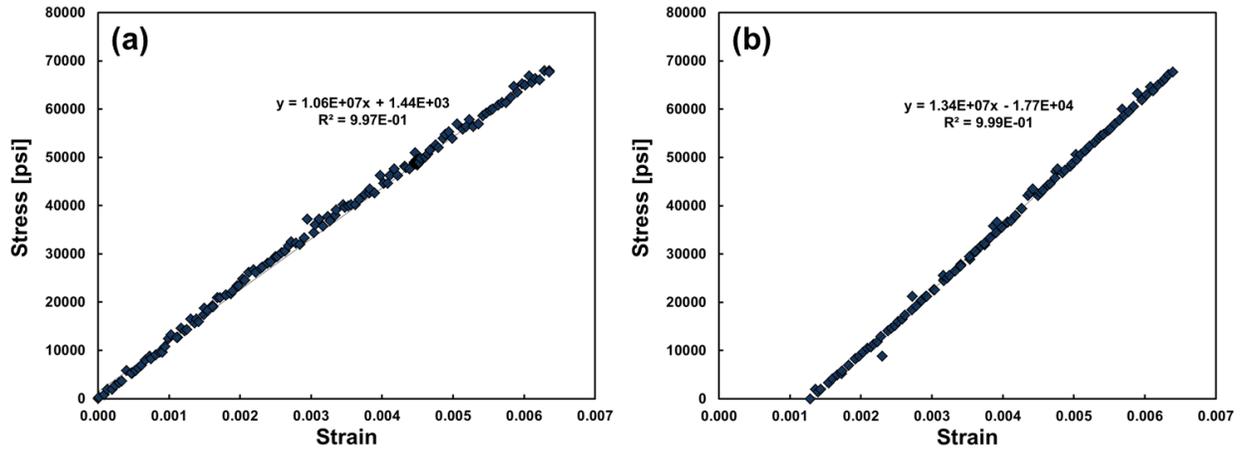
To confirm that the aluminum liners were annealed due to fire exposure, the primary hoop modulus from the first pressurization of ALT695-1781 after fire exposure was compared to the primary hoop modulus measured on a subsequent loading, see Figure 6.11. Clearly from Figure 6.11, ALT695-1781 was significantly more compliant on the first pressurization of the cylinder post fire exposure as compared to subsequent pressurizations (a difference of approximately 2.8 Msi). Such an occurrence was due to the 6061-T6 Aluminum being annealed and contributing virtually no stiffness to the cylinder on the first pressurization after fire exposure; in comparing the primary hoop modulus from the first pressurization of ALT695-1781 (Figure 6.11a) to the secondary hoop modulus of ALT695-1781 during the burst pressurization (Table 6.6), it is clear that the two moduli are identical (i.e., only the composite laminate is providing stiffness to the cylinder side wall) which confirms that the aluminum liner had been significantly annealed due to fire exposure. Furthermore, the plastic strain accumulated during the first pressurization for all cylinders' post fire exposure is summarized in Table 6.6 from which it is observed that the 6061-T6 Aluminum liners for all fire exposed cylinders were significantly annealed and accumulated a considerable amount of plastic deformation.

Figure 6.11 – (a) Primary hoop modulus of ALT695-1781 on the first pressurization post fire exposure, and (b) primary hoop modulus of ALT695-1781 on a subsequent pressurization.

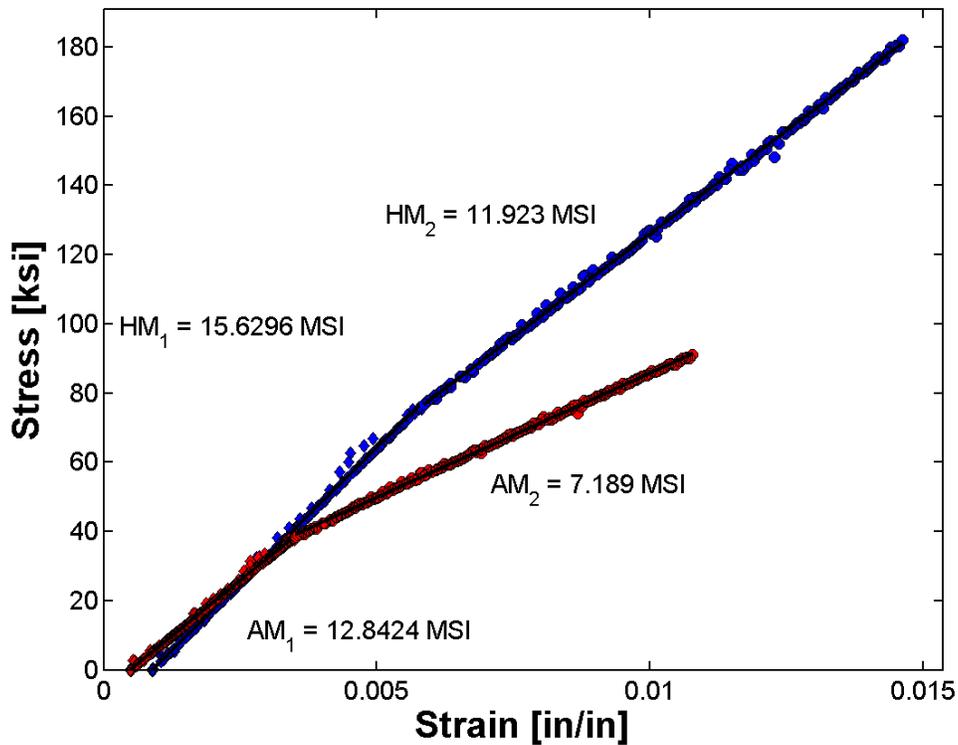
From a mechanical response perspective, cylinders were found to respond in a bi-modulus fashion in both the hoop and axial directions. Figure 6.12 provides the stress-strain response of ALT695 – 3669, from which the bi-modulus response in each of the principal directions can be observed. Up to the test pressure of the cylinders (7500 psig or 8500 psig if fatigue tested), the aluminum liner is contributing to the stiffness of the cylinder, whereas after the test pressure the aluminum is plastically deforming and its stiffness contribution to the cylinder wall becomes negligible.

Figure 6.12 – Hoop and axial stress-strain response of ALT695-3669. Note, blue symbols are hoop data, and red symbols are axial data.

Of note in Figure 6.12, it was observed that all strictly EOL burst cylinders had accumulated a certain amount of plastic deformation during the first test pressure cycle, which is measured by a residual tensile strain being present in the composite overwrap. Because the cylinders got so warm during the fire exposure, the 6061 Aluminum was annealed to a degree which lowered the yield strength of the liner. By subjecting the cylinders to a test pressure cycle prior to burst, the yield stress of the liner was once again raised and the characteristic bi-modulus response that has previously been observed [5] was again observed. The effects of annealing the 6061 T6 Aluminum liner were discussed in depth previously in this section. Appendix B provides the stress-strain response of all cylinders during the burst pressurization ramp, while Table 6.6 summarizes the primary and secondary hoop and axial moduli for all tested cylinders measured during the burst pressurization, as well as the measured plastic strain in each DOT-CFFC cylinder which was subjected to fire exposure.

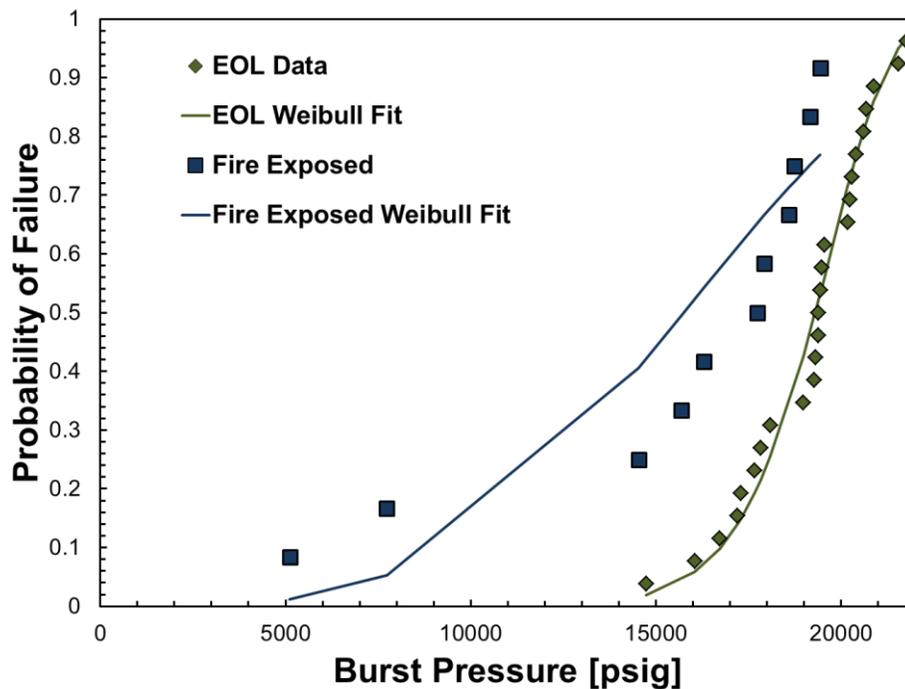
Also shown in Table 6.6 is the burst strength of the fire exposed cylinders, from which it is observed that cylinder burst strength is still adequate relative to service pressure for cylinders with minor to moderate Level 3 fire damage. Eight of nine cylinders with minor to moderate Level 3 fire exposure possessed burst strengths meeting DOT-CFFC 5<sup>th</sup> Revision, while the one cylinder which burst below DOT-CFFC 5<sup>th</sup> Revision requirements still had a burst to service pressure ratio of 3.23. While the burst strengths are adequate, Figure 6.13 shows that fire exposure damage (even minor to moderate as ranked in this report, but still to a CGA C.6.2 Level 3 damage) does statistically reduce the burst strengths of the cylinders when compared to only expired service life cylinder strength taken from [5].

Figure 6.13 – Comparison of EOL Burst strength data from as received expired service life cylinders taken from [5] and a Weibull distribution fit of the burst strengths of the fire exposed DOT-CFFC cylinders.

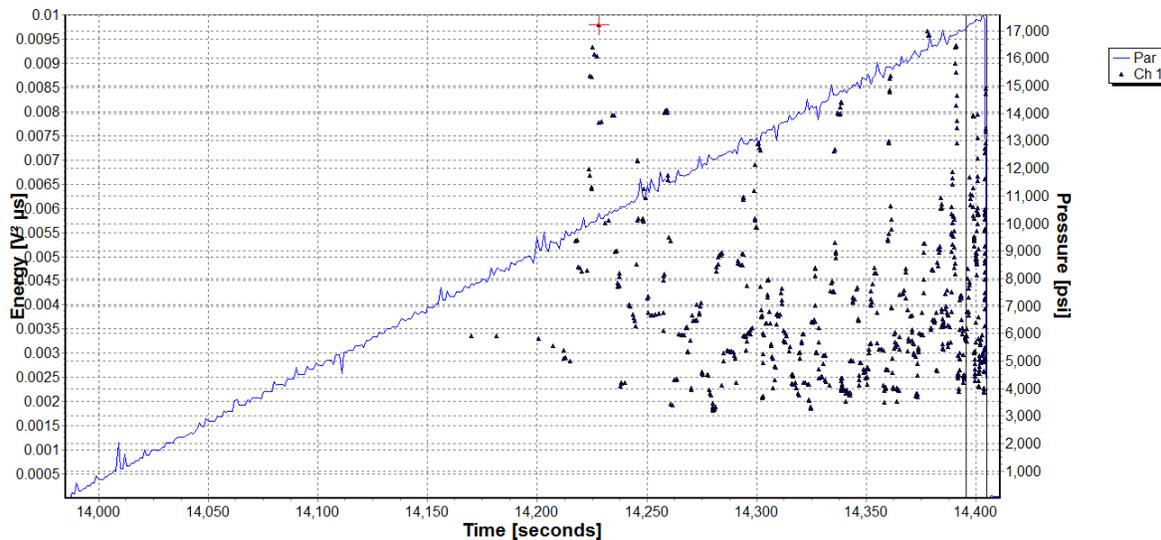
During the burst pressurization ramp of all five cylinders the Background Energy Oscillation Pressure (BEOP, as defined in [5]) was measured. Figure 7.1 provides the BEOP determination for cylinder OM3943 (BEOP = 10,371 psi), while all other BEOP plots are provided in Appendix C. In agreement with [5], Table 6.3 shows that the BEOP occurs at nominally 60% of the ultimate strength of a given cylinder, once again facilitating a predictive capability on the burst strength of the cylinder at pressures well below their respective strength.

Figure 7.1 – Background Energy Oscillation Pressure (BEOP) determination for OM3943.

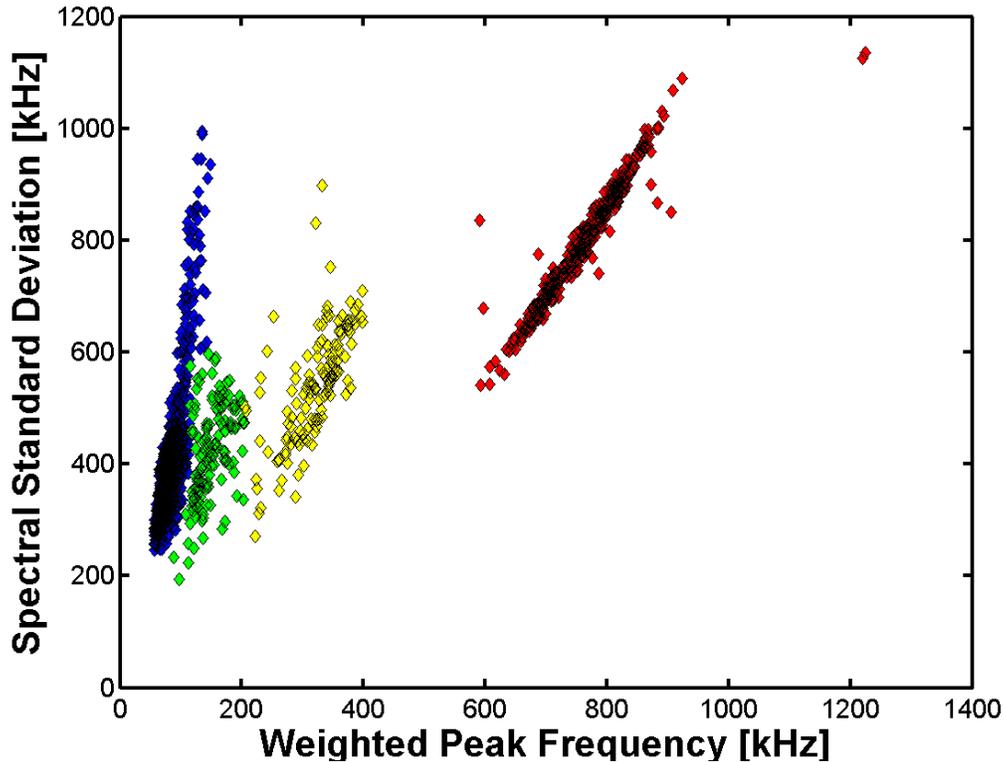
As an example, the spectral standard deviation versus the weighted peak frequency of ALT639 – 9573 is shown in Figure 7.2. In Figure 7.2, the blue markers are matrix cracking events, the green markers are interfacial/delamination events, the yellow markers are fiber fracture events, and the red markers are bulk mode detected fiber fracture events. As the cylinder was not subjected to any form of artificial damage (impact and/or notching) the two most prevalent types of damage mechanisms that were observed were matrix cracking and fiber fracture. Previously it has been reported that cylinders with simulated damage emit a comparatively larger number of delamination events [5]. In agreement with statistical fiber strength models, no fiber fracture events were observed for ALT639 – 9573 until the cylinder had been pressurized to 58% of its ultimate burst strength. As all five cylinders that were burst were not subjected to an artificial form of damage, all cylinders performed in a manner consistent with ALT639 – 9573. Plots of the spectral standard deviation versus *MF* are provided in Appendix D.

Figure 7.2 – Spectral standard deviation versus *MF* for ALT639-9573.

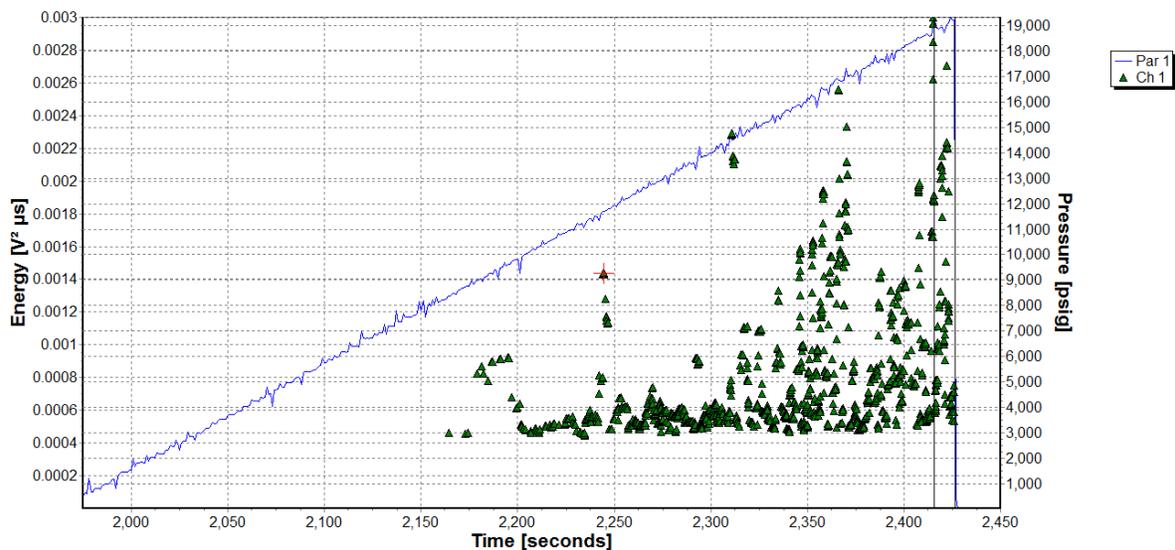
During the burst pressurization ramp of all fourteen cylinders, the Background Energy Oscillation Pressure (BEOP, as defined in [5]) was measured. Figure 7.3 provides the BEOP determination for cylinder ALT639 - 70015 (BEOP = 11,690 psig), while all other BEOP plots are provided in Appendix C. In agreement with [5], Table 6.4 shows that the BEOP occurs at an average value of 60% of the ultimate strength of a given cylinder, once again facilitating a predictive capability on the burst strength of the cylinder at pressures well below their respective strength. With such a predictive capability, cylinders with compromised burst strength may be identified and removed from service enhancing the safety of the public.

Figure 7.3 – Background Energy Oscillation Pressure (BEOP) determination for ALT639-70015.

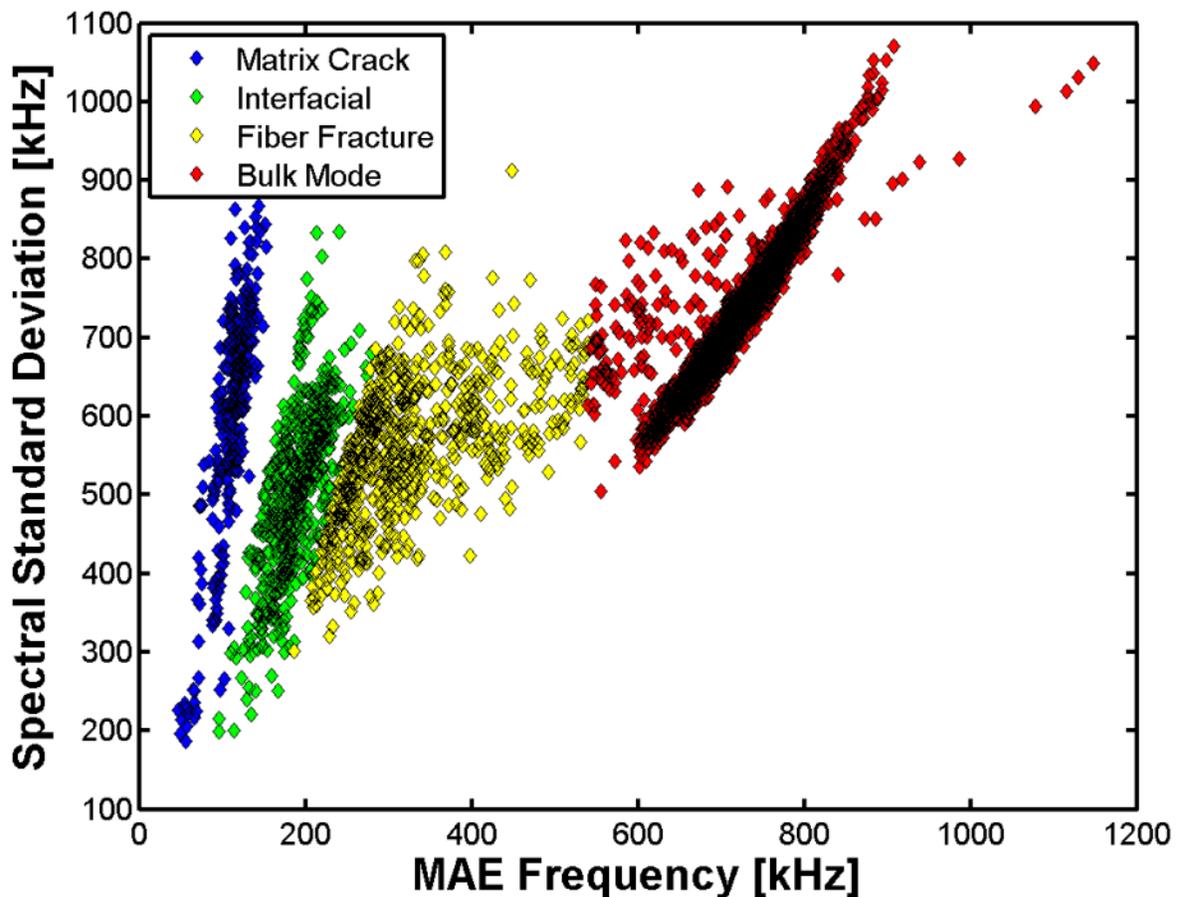
As an example, the spectral standard deviation versus the  $MF$  of ALT639 – 70015 is shown in Figure 7.4. In Figure 7.4, the blue markers indicate matrix cracking events, the green markers indicate interfacial failure events (fiber/matrix debonding and delamination), the yellow markers indicate fiber fracture events, and the red markers indicate bulk mode fiber fracture events. As the cylinder was not subjected to any form of artificial damage (impact and/or notching) the occurrence of damage mechanisms was more or less uniform. Previously it has been reported that cylinders with simulated damage emit a comparatively larger number of delamination events [5]. In agreement with statistical fiber strength models, no fiber fracture events were observed for ALT639 – 70015 until the cylinder had been pressurized to 56% of its ultimate burst strength. As all fourteen cylinders that were subjected to a burst pressurization were not subjected to an artificial form of damage, all cylinders performed in a manner consistent with ALT639 – 70015. Plots of the spectral standard deviation versus  $MF$  are provided in Appendix D.

Figure 7.4 – Spectral standard deviation versus  $MF$  for ALT639 - 70015.

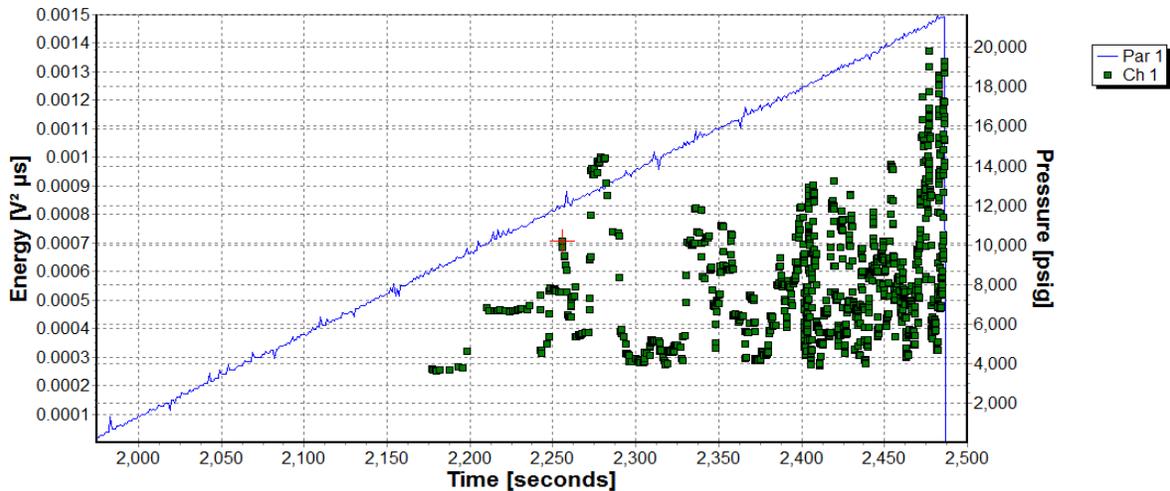
During the burst pressurization ramp of all ten cylinders, the Background Energy Oscillation Pressure (BEOP, as defined in [5]) was measured. Figure 7.5 provides the BEOP determination for cylinder ALT639 - 95898 (BEOP = 11,960 psig), while all other BEOP plots are provided in Appendix C. In agreement with [5], Table 6.5 shows that the BEOP occurs at an average value of 60% of the ultimate strength of a given cylinder, once again facilitating a predictive capability on the burst strength of the cylinder at pressures well below their respective strength. With such a predictive capability, cylinders with compromised burst strength may be identified and removed from service enhancing the safety of the public.

Figure 7.5 – Background Energy Oscillation Pressure (BEOP) determination for ALT639-95898.

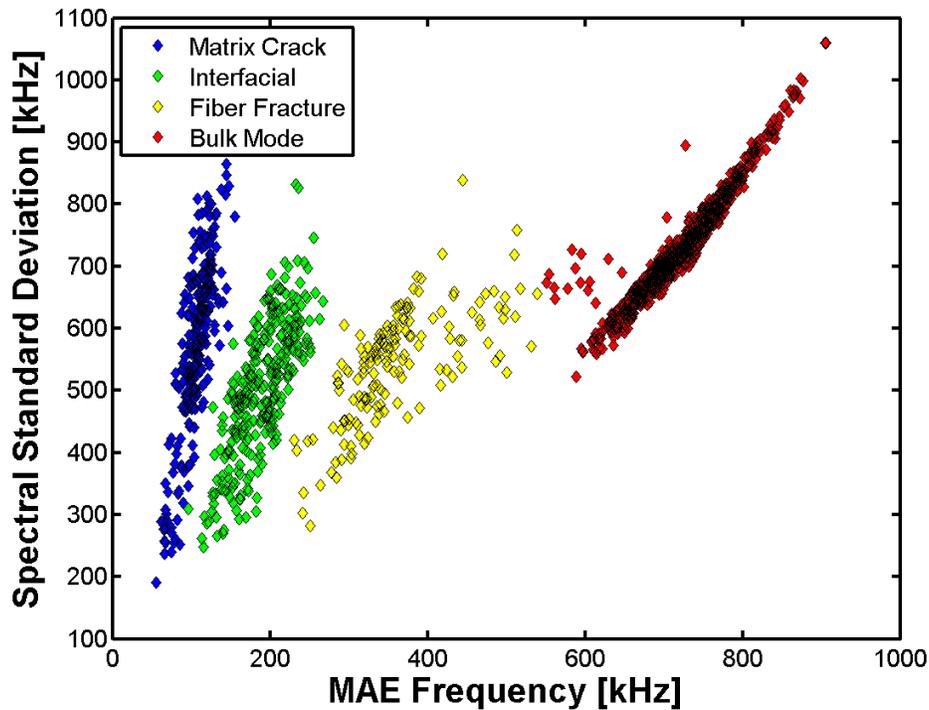
As an example, the spectral standard deviation versus the  $MF$  of ALT639 – 95898 is shown in Figure 7.6. In Figure 7.6, the blue markers indicate matrix cracking events, the green markers indicate interfacial failure events (fiber/matrix debonding and delamination), the yellow markers indicate fiber fracture events, and the red markers indicate bulk mode fiber fracture events. As the cylinder was not subjected to any form of artificial damage (impact and/or notching) the

occurrence of damage mechanisms was more or less uniform. Previously it has been reported that cylinders with simulated damage emit a comparatively larger number of delamination events [5]. In agreement with statistical fiber strength models, no fiber fracture events were observed for ALT639 – 95898 until the cylinder had been pressurized to 57% of its ultimate burst strength. As all ten cylinders that were subjected to a burst pressurization were not subjected to an artificial form of damage, all cylinders performed in a manner consistent with ALT639 – 95898. Plots of the spectral standard deviation versus *MF* are provided in Appendix D.

Figure 7.6- Spectral standard deviation versus *MF* for ALT639 - 95898.

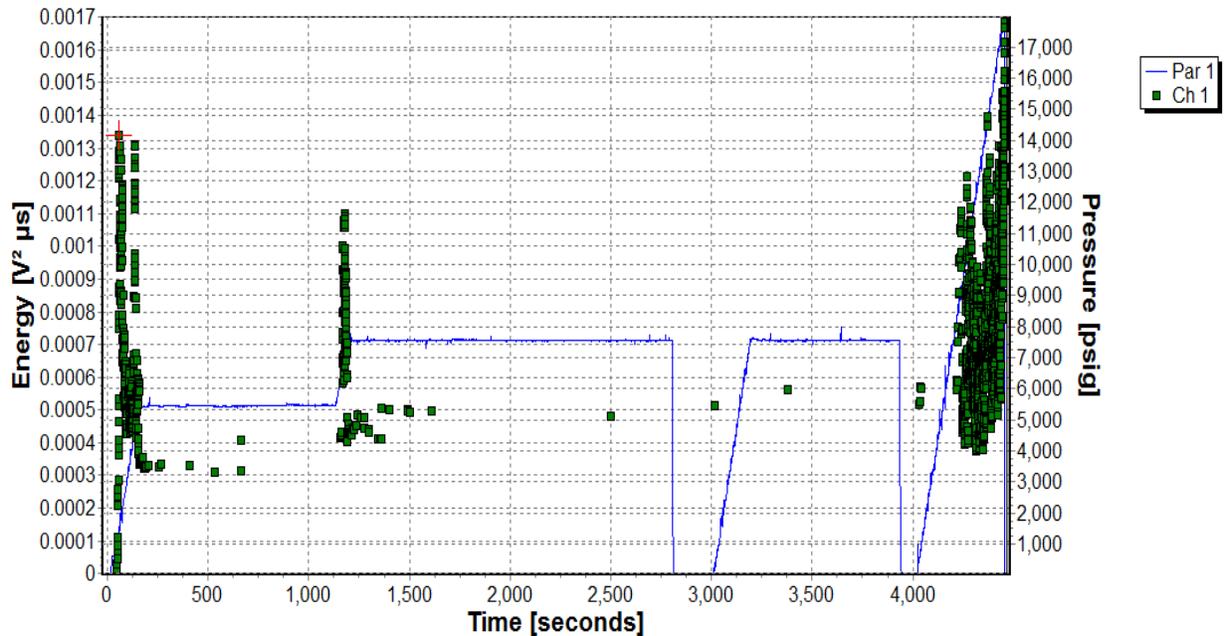
Prior to the burst pressurization of the fire exposed cylinders, the pressure schedule and the MAE accept/reject criteria of [5] were followed and evaluated to assess the integrity of the particular cylinder. In evaluating the MAE accept/reject criteria of [5], all fire exposed cylinders failed due to violating a multitude of the criteria on both the first and second test pressure cycles. Due to the cylinders having a new damage state introduced to the composite microstructure and not experiencing any fatigue cycles to develop their new characteristic damage state, all fire exposed cylinders violated several modal acoustic emission accept/reject criteria (see Table 6.6). Such findings indicate that MAE can be used to evaluate the severity of fire exposure as opposed to relying on the currently used visual inspection techniques of [12]. Of particular value in investigating the fire exposure of cylinders, it was found that the Background Energy began oscillating at very low pressures (Table 6.6), as compared to previously tested expired service life cylinders [5]. Figure 7.7 provides a representative Background Energy Oscillation (BEO) plot of ALT 695-1781 in which oscillation is observed on

both the first test pressure cycle, as well as on the burst pressurization. Appendix C provides BEO plots for the fire exposed cylinders addressed in this report. Due to the unique response of the fire exposed DOT-CFFC cylinders two BEOP were measured; the first BEOP measurement was taken on the first pressurization of the cylinder after being exposed to the fire, the second BEOP measurement was taken on the burst pressurization cycle of the cylinder (Table 6.6).

**Figure 7.7 – Background Energy Oscillation plot of ALT695-1781.**

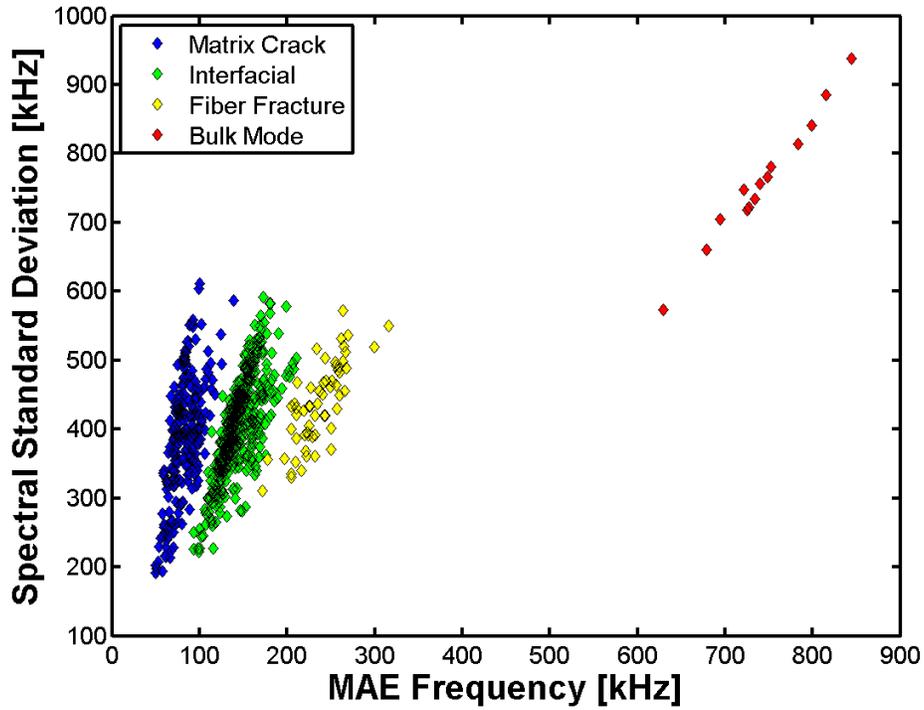
From a Modal Acoustic Emission perspective, all fire exposed cylinders with minor to moderate fire damage performed in a similar fashion. Due to the oxidation of the sacrificial layer, a majority of the detected events during the first pressurization of the cylinder after the fire exposure were matrix cracking and interfacial failure (e.g., see ALT639-23371 as a representative example, Figure 7.8), whereas during the burst pressurization a far greater percentage of the detected events were fiber fracture (Figure 7.9). Burks and Kumosa have previously investigated thermally oxidized hybrid polymer matrix composite structures using Modal Acoustic Emission with Scanning Electron Microscopy confirmation, and concluded that matrix cracking of the oxidized layer and fiber/matrix debonding (interfacial failure) were the primarily observed failure mechanisms during the first loading after oxidation [19].

Figure 7.8 – Signal classification of detected acoustic emissions from ALT639-23371 during the first test pressure cycle after fire exposure.

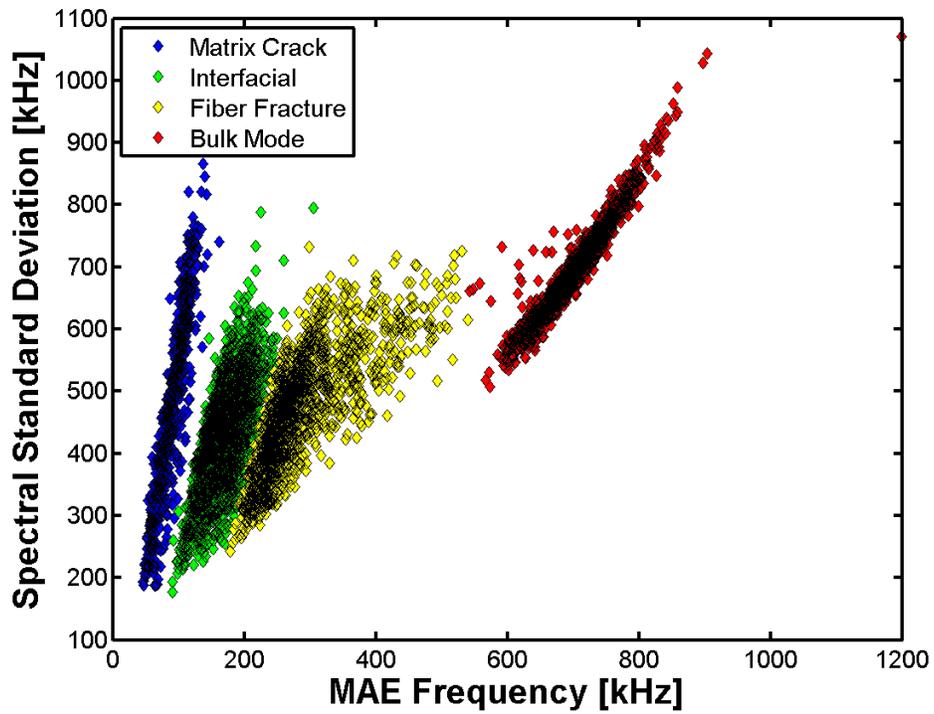
Figure 7.9 - Signal classification of detected acoustic emissions from ALT639-23371 during the burst pressure cycle.

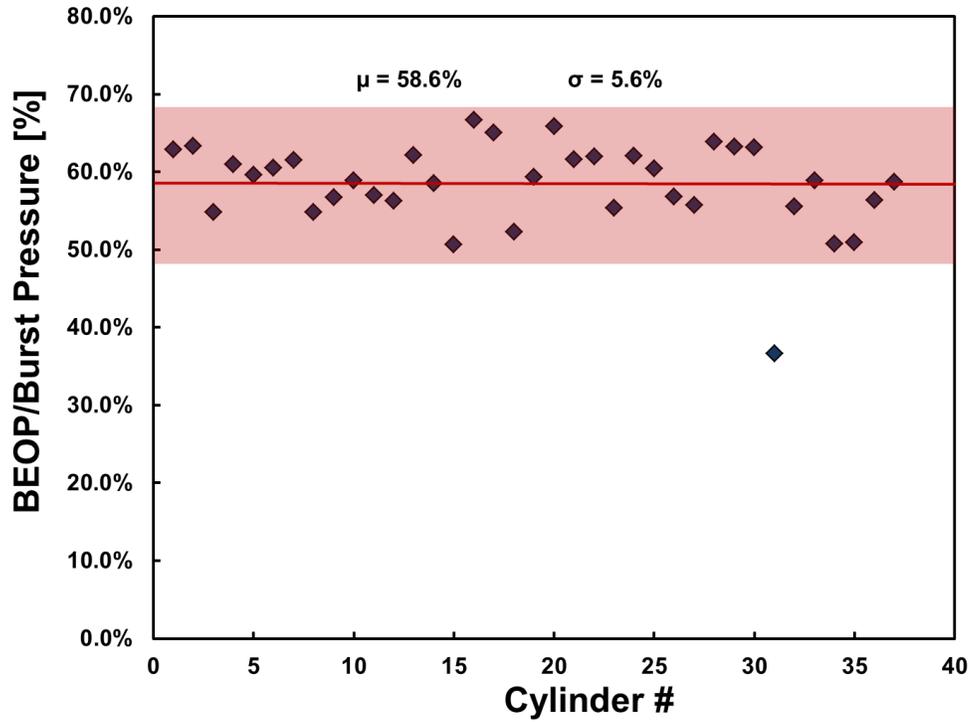
In looking at the ratio of Background Energy Oscillation Pressure (BEOP) on the cycle in which the cylinder burst to the cylinder's burst pressure (Figure 7.12), for all cylinders considered in this work, it is observed that the BEOP occurs on average at 58.6% of the cylinders strength, with a standard deviation of 5.6%. Such findings highlight MAE's ability to predict burst strength of the composite pressure cylinders. Figure 7.13 also shows the extremely strong correlation between BEOP from the burst pressure cycle and the cylinder ultimate burst pressure. The strong one-to-one relationship which exists between a cylinder's BEOP and its ultimate burst strength has been described in depth [5, 20], and is a key component of the MAE inspection technique insuring that compromised cylinders may be properly identified and removed from service, enhancing public safety.

Figure 7.12 – Ratio of BEOP to Burst Pressure for all cylinders which were catastrophically burst in this study. The mean ( $\mu$ ) value and two standard deviation ( $2\sigma$ ) bounds are also included.

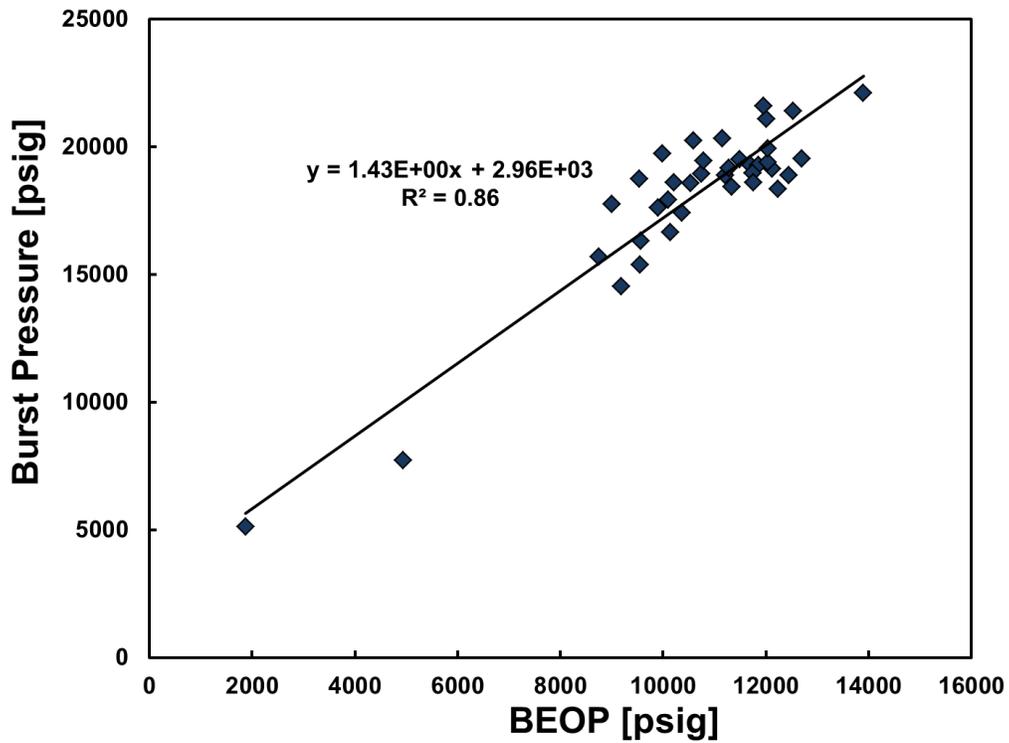
Figure 7.13 – Cylinder burst pressure vs. background energy oscillation pressure for all cylinders burst test in this environmental effects study.

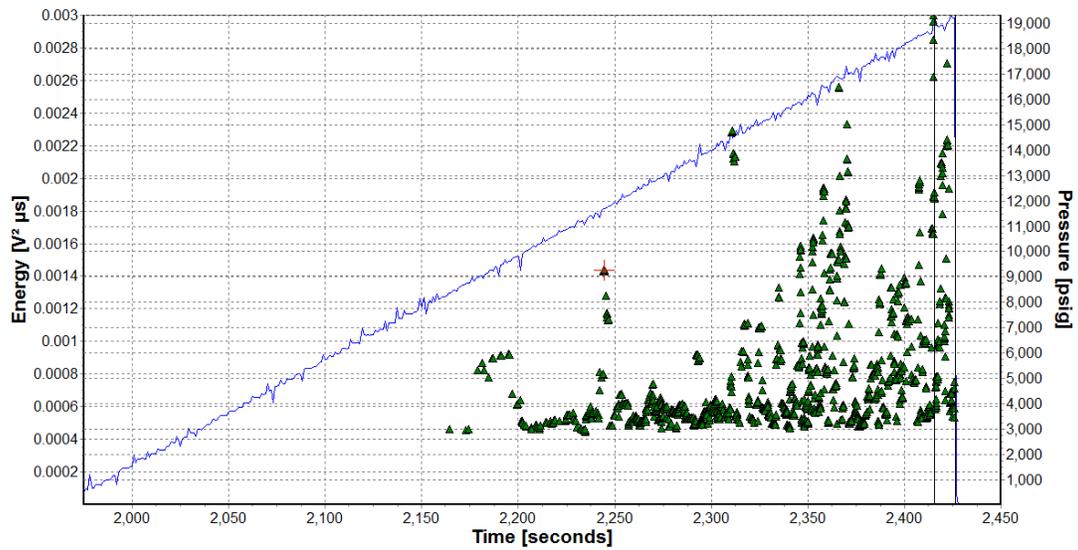
Figure C.6 – Background Energy Oscillation Pressure determination of ALT639 - 70015.

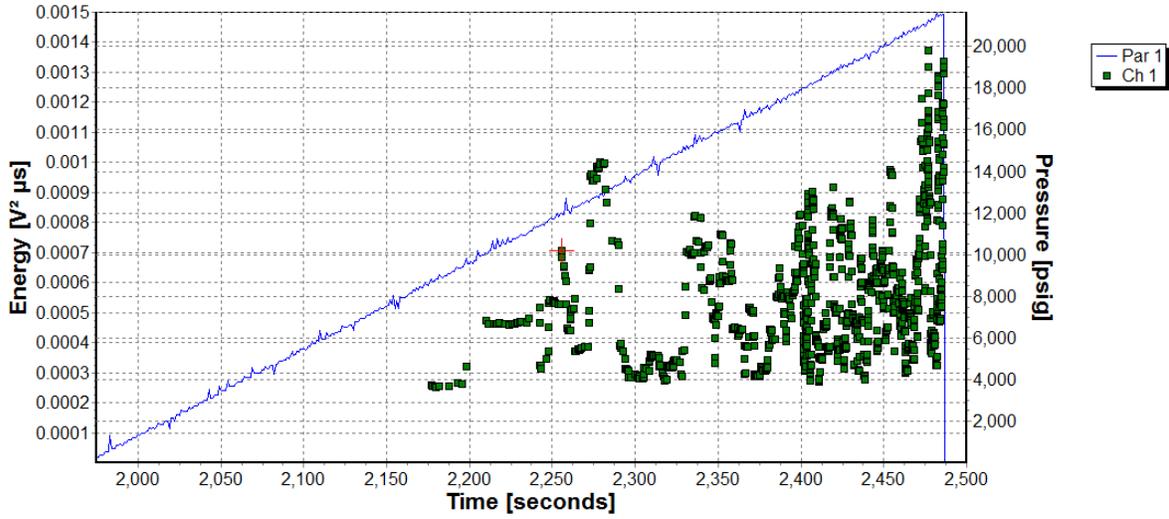
Figure C.21 – Background Energy Oscillation Pressure determination of ALT639 - 95898.

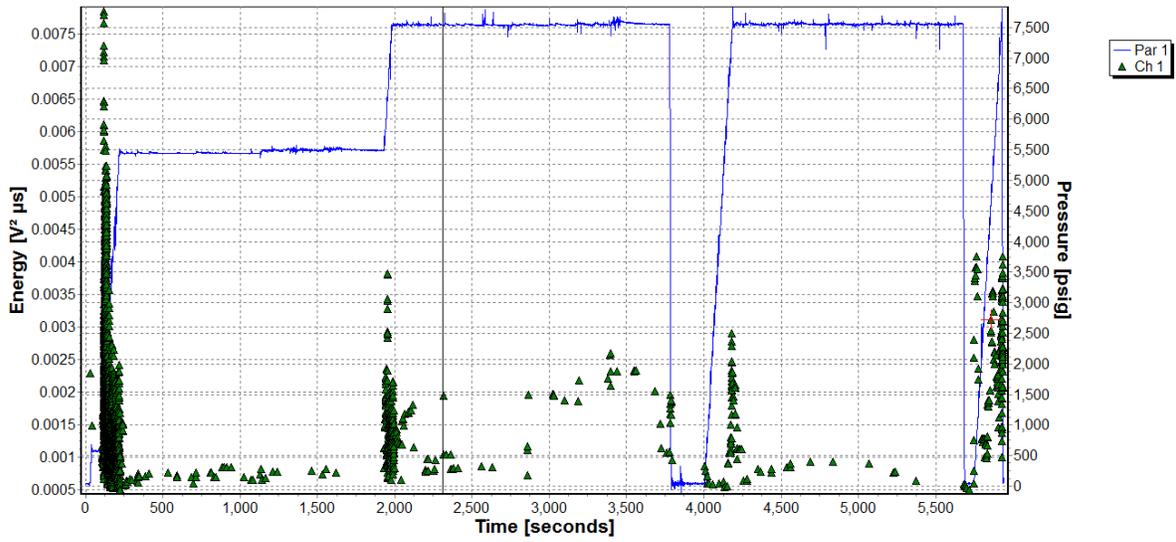
In looking at the Modal Acoustic Emission performance of the cylinders with severe fire damage (ALT639-17831, ALT639-9769, and ALT604-3764), several key characteristics were identified that were not observed in the minor to moderately fire damaged cylinders. As compared to the minor and moderately fire damaged cylinders, the level of visual fire damage was significant with obvious fiber tow unwrapping and a loss (or decomposition) of epoxy resin (Figure 7.10). Moreover, as opposed to the cylinders with minor to moderate fire damage, cylinders with severe fire damage exhibited numerous partial-to-multiple fiber tow fracture events at extremely low pressures during the first test pressure cycle. Figure 7.11 shows a multiple fiber tow fracture event which occurred on the first pressurization of ALT639-17831 at a pressure of 1700 psig in which approximately 60k filaments (or five 12k fiber tows) fractured. Such severe fiber fracture damage occurring at only 1700 psig of a 4500 psi service pressure DOT-CFFC cylinder suggests that a significant level of damage has occurred to the cylinder; the MAE test should be suspended and the cylinder condemned immediately.

Figure C.29 – Background Energy Oscillation Pressure plot of ALT639-17831.

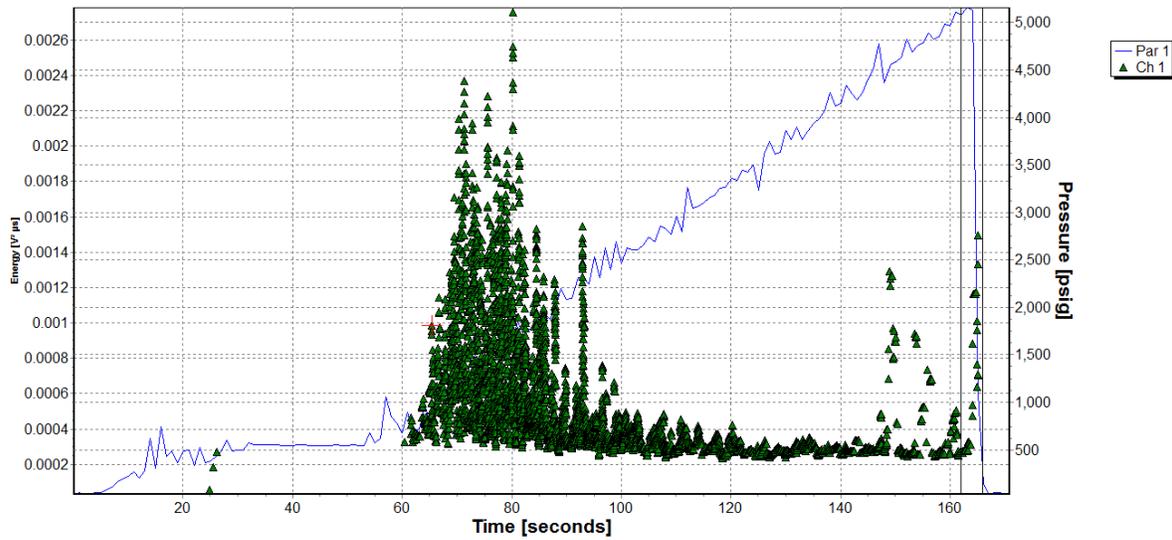
Figure C.32 – Background Energy Oscillation Pressure plot of ALT639-9769.

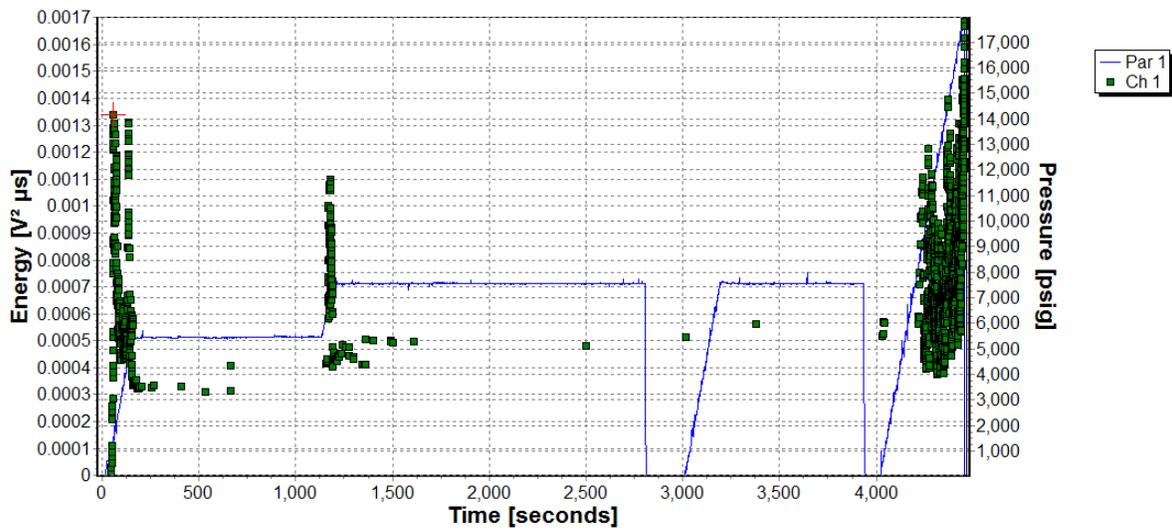
Figure C.36 – Background Energy Oscillation Pressure plot of ALT695-1781.

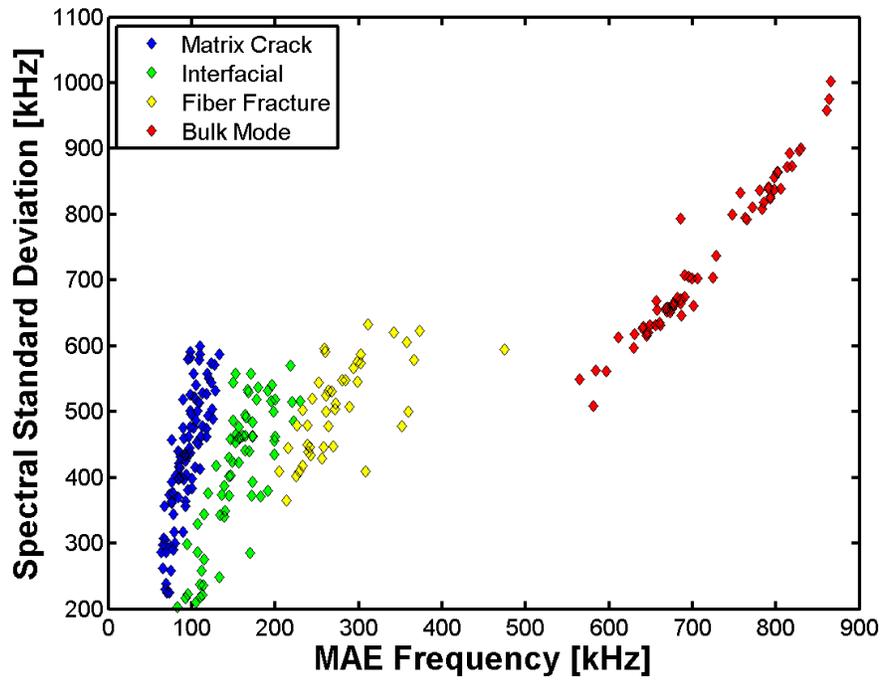
Figure D.21 – Spectral standard deviation versus Modal Acoustic Emission Frequency for ALT639 - 95898.

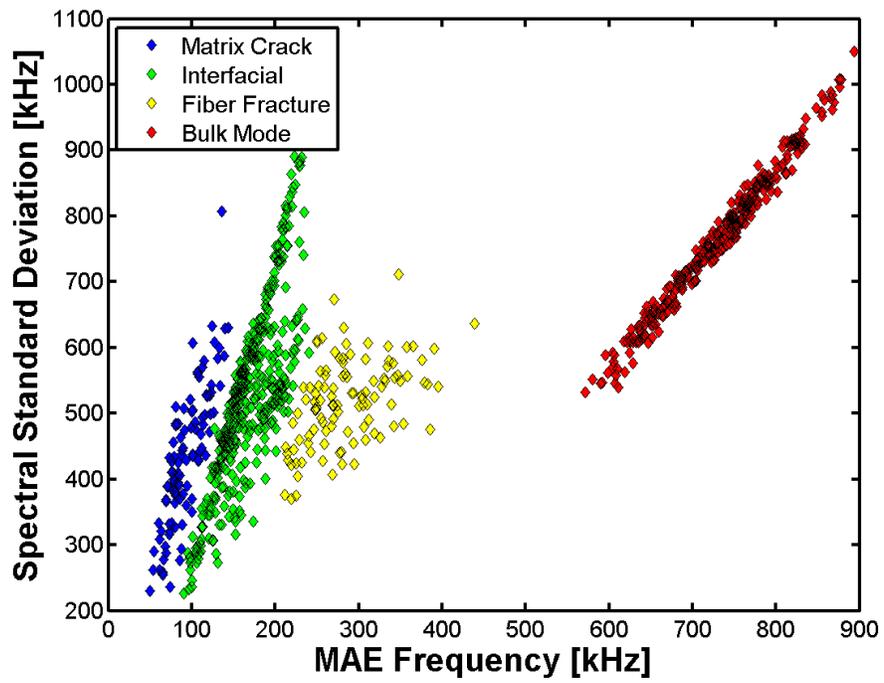
Figure D.30 – Source mechanism classification plot for ALT639-17831.

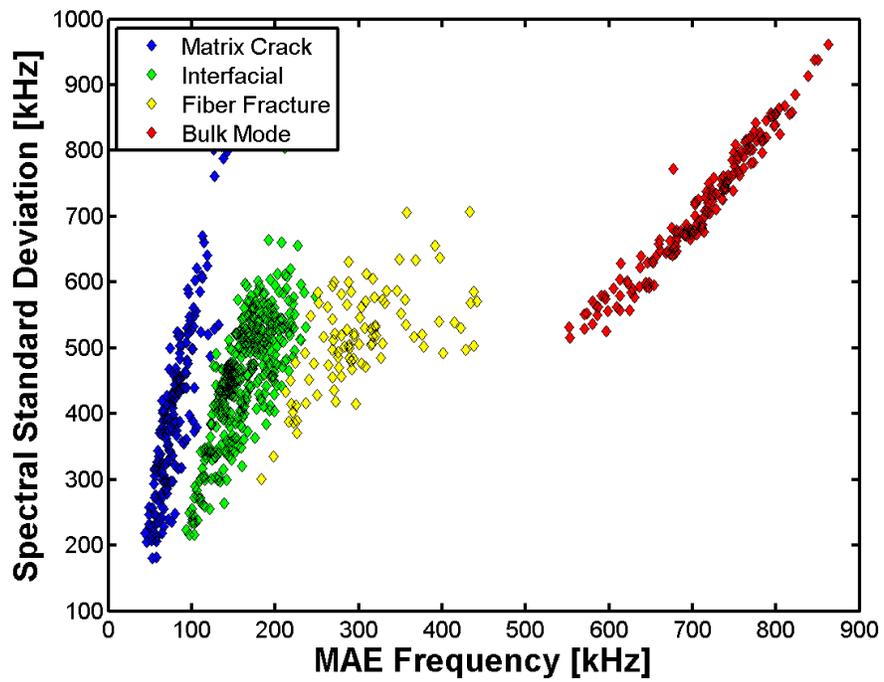
Figure D.33 – Source mechanism classification plot for ALT639-9769.

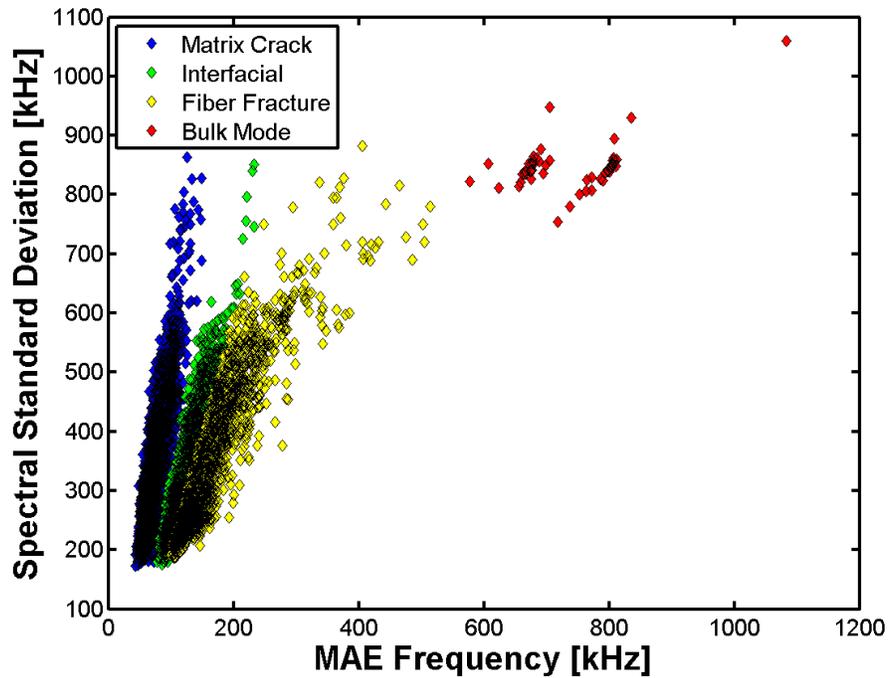
Figure D.37 – Source mechanism classification plot for ALT695-1781.

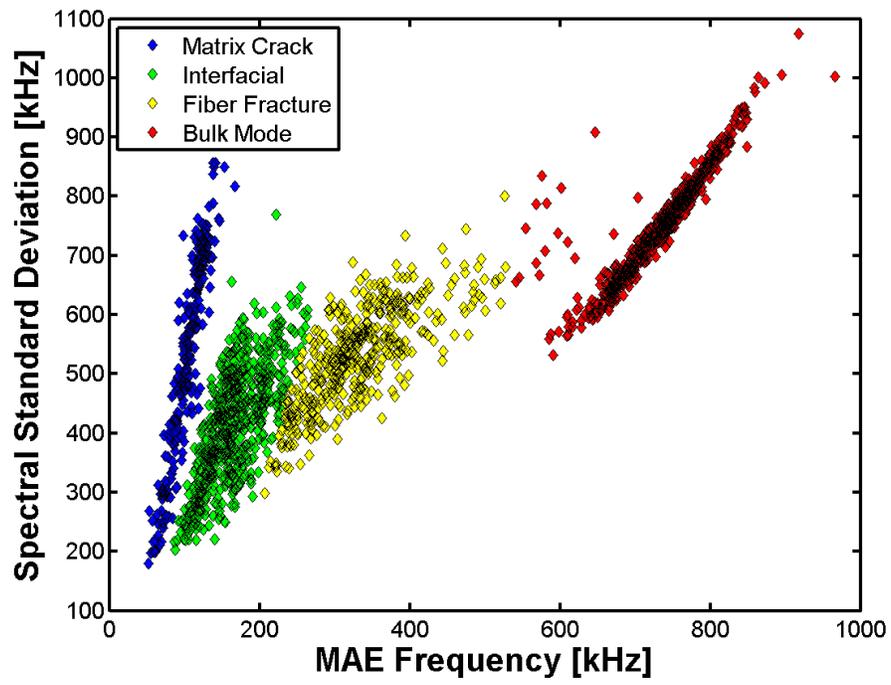
Figure D.38 – Source mechanism classification plot for OM3930.

DOT SPECIAL PERMIT: 10915  
SERIAL #: OM3930  
DATE OF MANUFACTURE: 05/98  
BURST TEST DATE: N/A  
CYCLES: LEAKED AT 6,926 CYCLES  
FLAWS: FIRE EXPOSURE  
BURST PRESSURE: N/A
